## INSPECTION REPORT: KENSINGTON GOLD MINE

Date of Inspection: Tuesday May 8, 2018  
Date of Report: Wednesday May 23, 2018  
USDA Forest Service Inspector: Richard Dudek

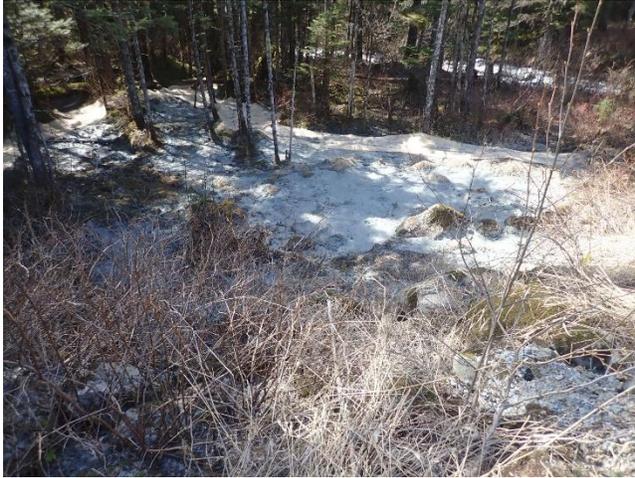
- **Sediments accumulation near the bridge 2 south abutment. Coeur Alaska placed jute mats down to prevent sediments from entering Johnson Creek. However, mitigations are required to prevent additional sediment loading, and sediments from entering Johnson Creek.**

The access roads were in good condition (2016 BMP Plan; Table 4-4). At Bridge 2, sediment accumulation was observed downgradient of the south abutment near Johnson Creek (Photos 1-2). Coeur Alaska is aware of this and stated the accumulation resulted from meltwater flowing out of the

access road ditch. Surface Operations placed jute mats down as a control to prevent sediments from flowing into Johnson Creek.

**Photo 1. Sediments have flowed out from a ditch near Bridge 2.**

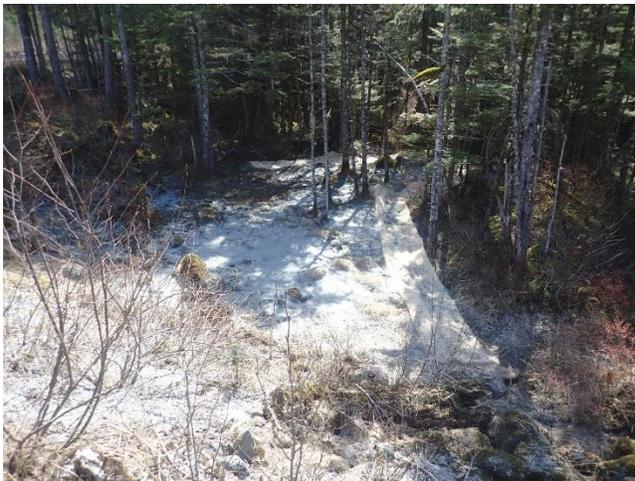
**Photo 2. Jute mats are in place to prevent sediments from entering Johnson Creek near Bridge 2.**

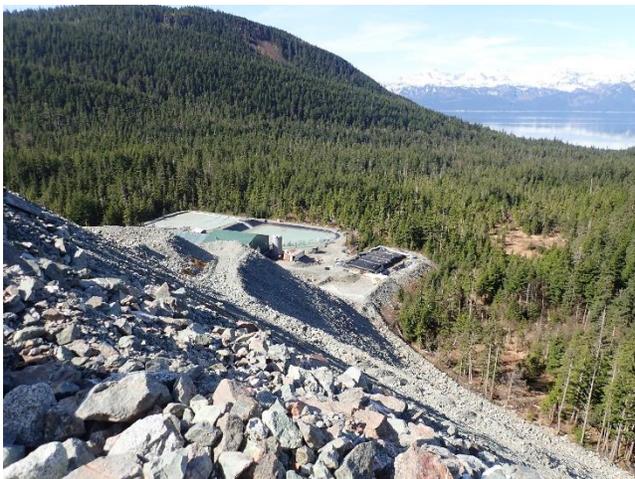
Coeur Alaska continues to deposit waste rock from the Raven drift at this location (Photos 3-4).

**Photo 3. The Comet development pile.**

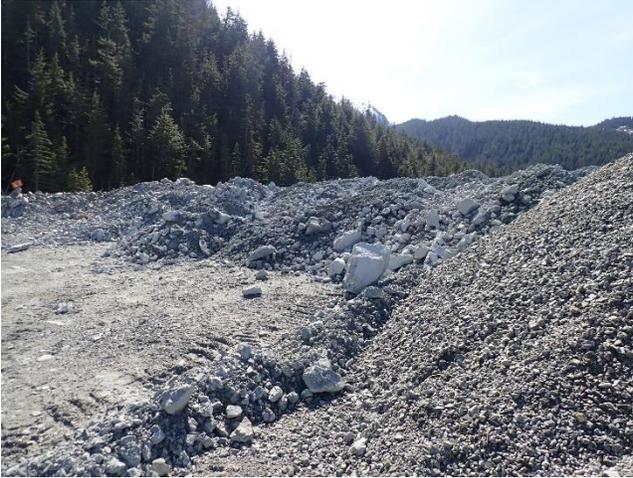
**Photo 4. Recently deposited waste rock from the Raven drift.**

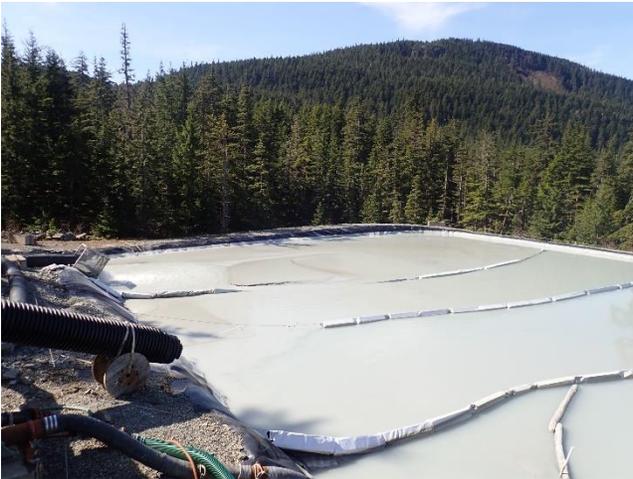
On 05/08/2018, the CWTP was treating 1,436 gallons per minute. Pond-1 (Photo 5) was receiving mine site water, and Pond-2 (Photo 6) was receiving backwash from the CWTP. Coeur Alaska has plans to dredge both ponds, and during that process, the CWTP personnel will install new silt curtains in Pond-1. Good housekeeping practices (2016 BMP plan Table 4-1) were observed inside the CWTP.

**Photo 5. CWTP's pond 1.**

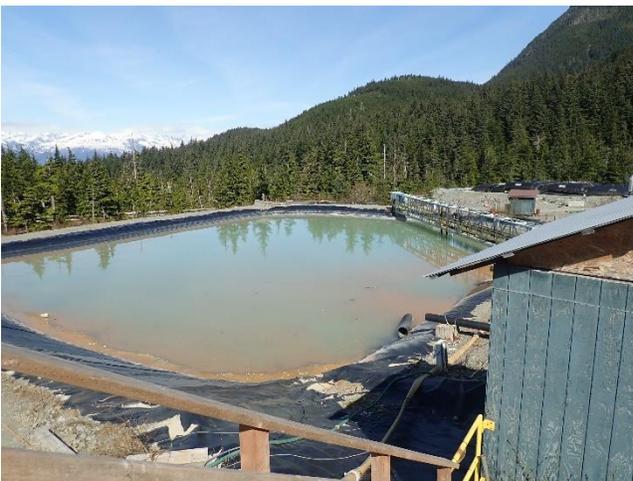
**Photo 6. The CWTP's Pond 2.**

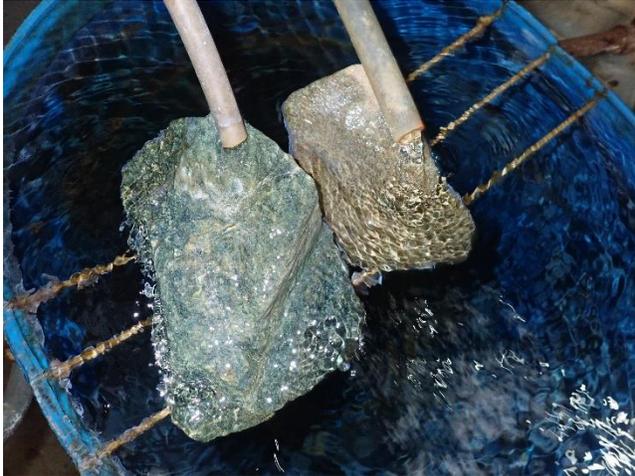
White material was not observed on the test rocks used for monitoring white material in treated mine site water (Photo 7). CWTP personnel continue to use calcium chloride (CaCl<sub>2</sub>) to remove white material out of solution during the water treatment process (Photo 8).

Photo 7. The test rocks used for monitoring white material accumulation.

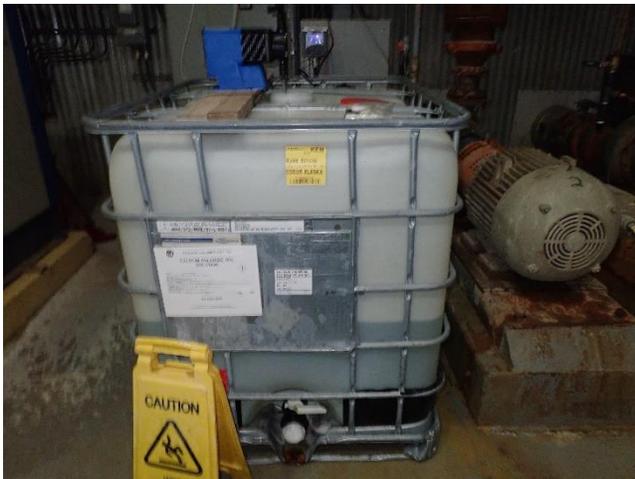
Photo 8. A 300-gallon tote with Calcium Chloride ( $\text{CaCl}_2$ ).

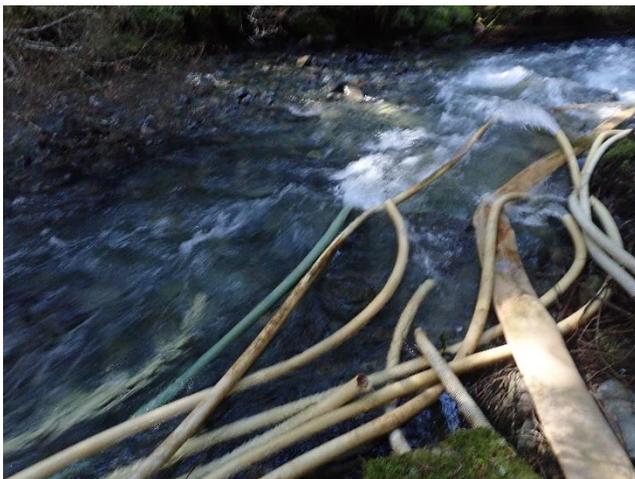
White material was not observed in Sherman Creek (Photo 9).

Photo 9. Sherman Creek Outfall (Outfall 002).

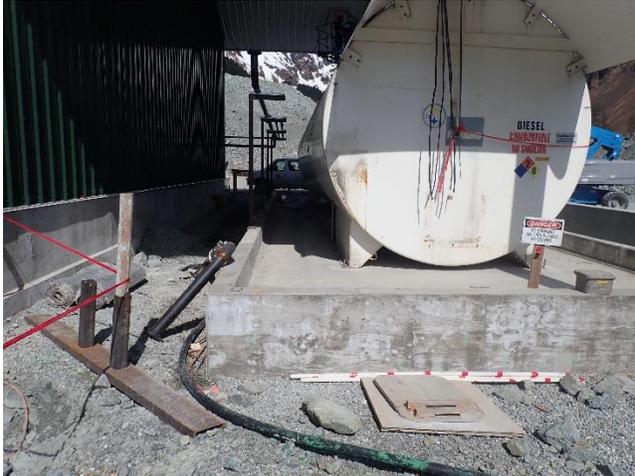
Contractors were in the process of connecting the 30,000-gallon day tank to the new powerhouse (Photo 10). A 1,000-gallon fuel tank is currently being used for refueling.

**Photo 10. The 30,000-gallon day tank.**

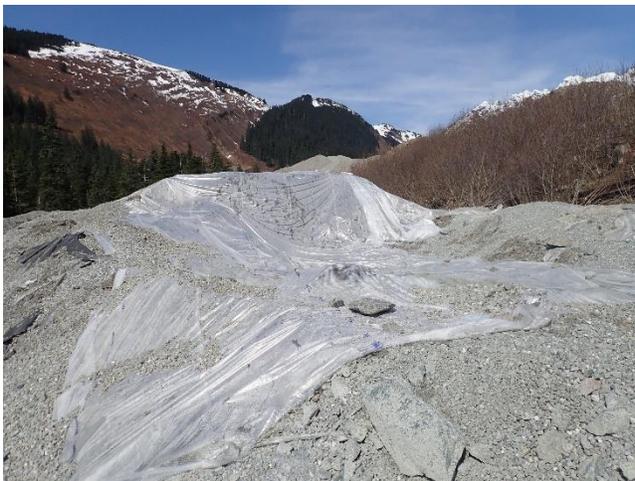
The temporary Graphitic Phyllite (GP) stockpile was covered with a liner (Photo 11).

**Photo 11. A temporary GP stockpile located at the south end of the mud dump.**

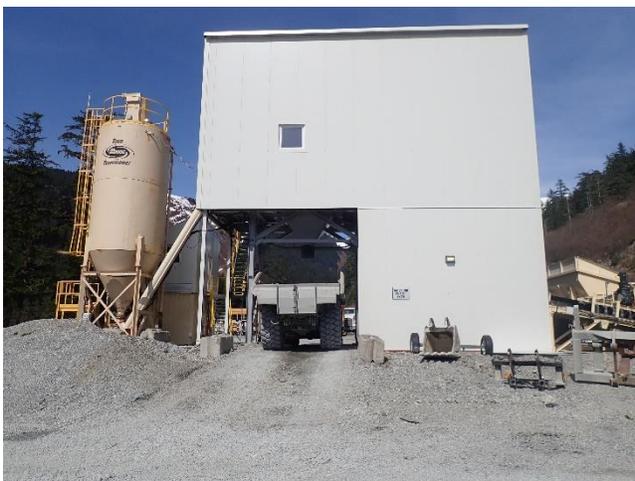
The Pug plant (Photo 12) is operational and approximately 2,300 tons of GP material has been mixed with cement and taken underground for backfilling the stopes. When not in use, the GP feedstock pile should remain covered to reduce the potential for acid generation (Photo 13).

**Photo 12. The Pug plant located at Pit 4.**

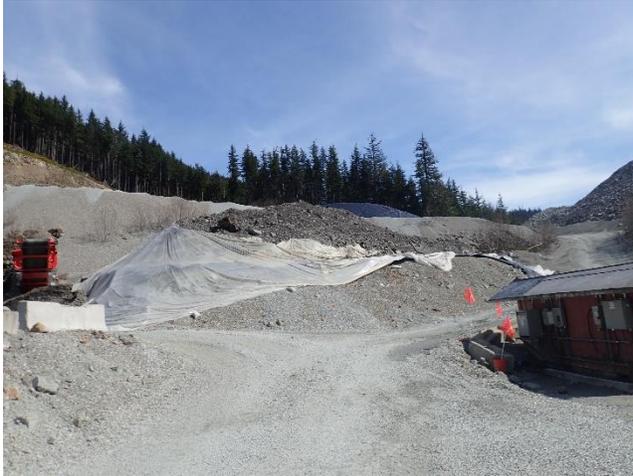
**Photo 13. The GP feedstock pile located at Pit 4.**

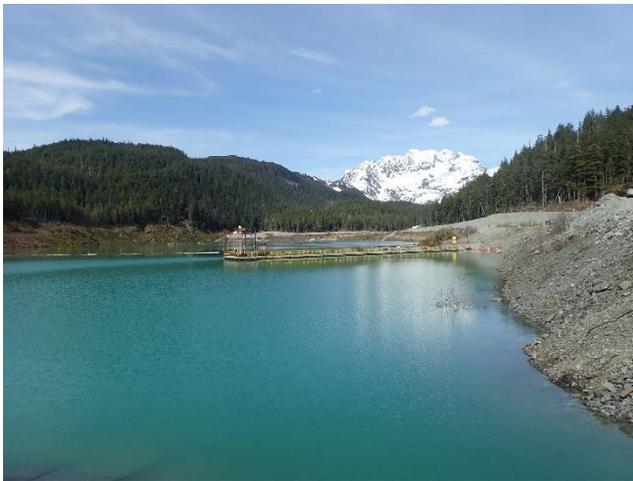
The TTF's recorded water level on 05/9/2018 was 703.5 feet (Photo 14).

**Photo 14. The tailing treatment facility (TTF).**

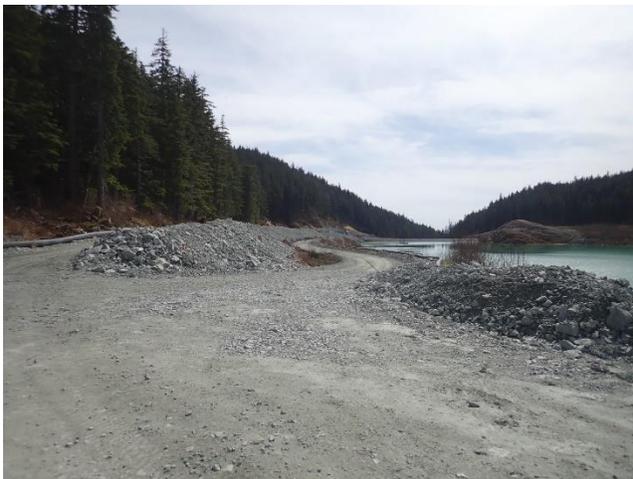
The east access road re-alignment/raise is completed (Photo 15), and below the stage 2 dam, contractors were in the beginning stages (Photo 16) for the TTF stage 3 dam's construction expansion.

**Photo 15. The east access road was raised approximately 25 feet.**

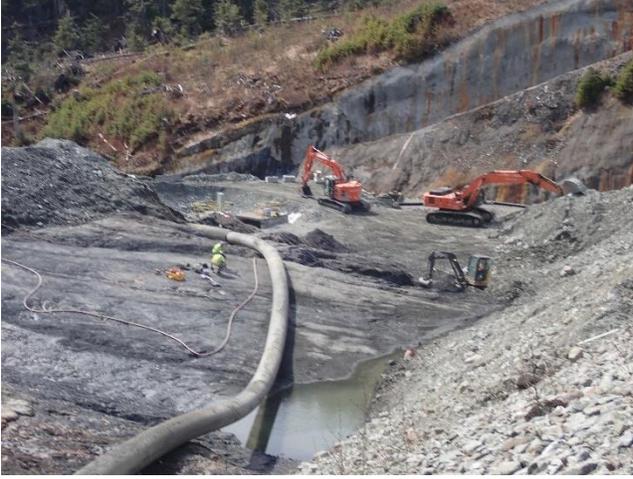
**Photo 16. Contractors excavating rock for stage 3 dam construction.**

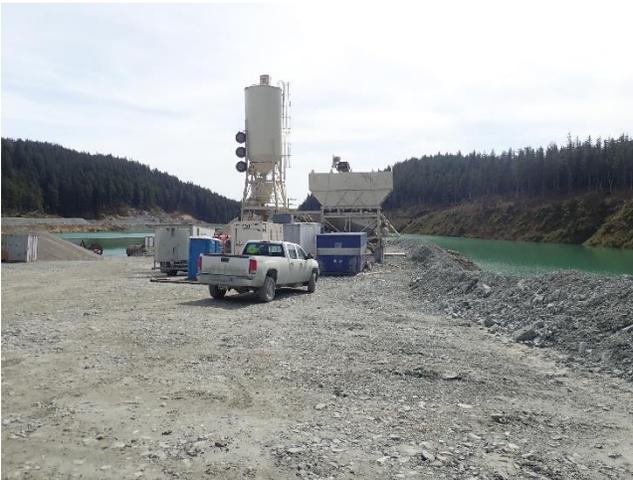
In the northern TTF laydown area, contractors have staged a cement batch plant that will generate the concrete for the stage 3 dam construction (Photo 17). At the time of the inspection, the lined ditch that collects acid rock drainage (ARD) had no ARD accumulation (Photo 18).

**Photo 17. The cement batch plant located at the northern TTF laydown area.**

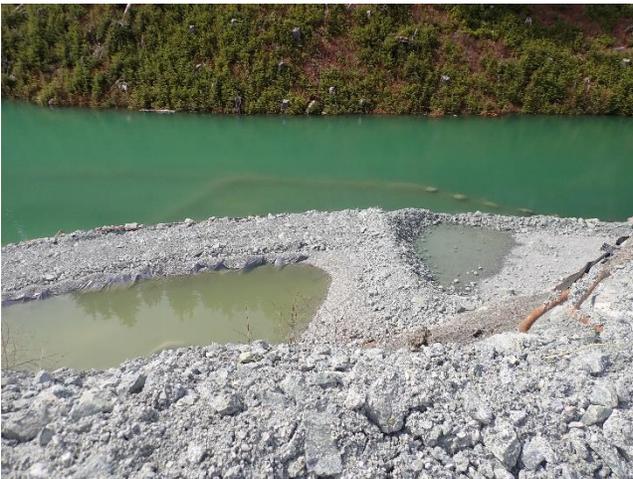
**Photo 18. The northern TTF area lined ARD ditches.**

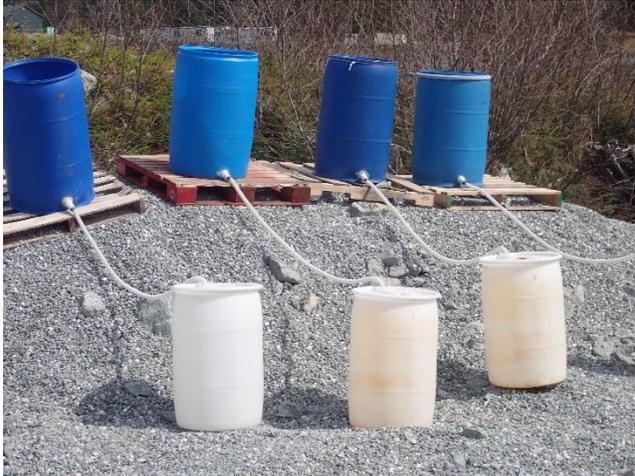
The Graphitic Phyllite (GP) cells (ARD test barrels) hoses were connected to the ARD collection barrels (Photo 19).

**Photo 19. The GP test barrels.**

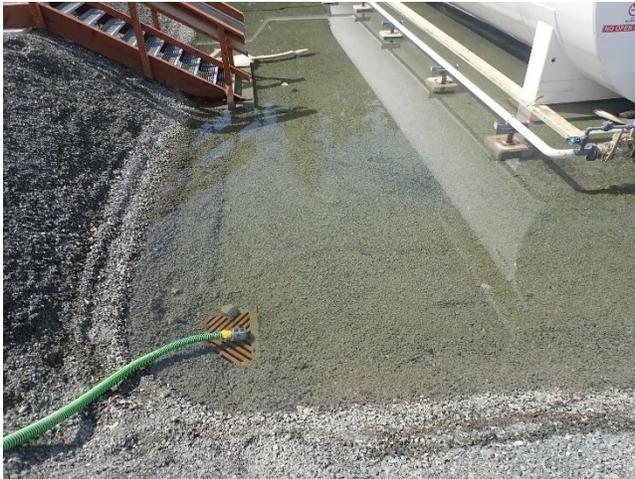
At the time of the inspection, the Fuel Depot Operators were pumping out accumulated precipitation from the fuel farm and into the refueling pad (Photo 20). All accumulation is removed when it impacts the farm's secondary containment's capacity to store 110% of the volume from a single tank. Hydrocarbon booms and absorbent pads were placed inside the refueling pad's drain to capture any fuel that was mixed with water (Photo 21). Water discharging from the refueling pad's outlet drain was emptying into a tote with hydrocarbon absorbent pads (Photo 22). This was done as a final precaution to ensure all possible hydrocarbons are captured prior to discharging into the environment.

**Photo 20. Meltwater accumulation being pumped out of the fuel farm.**

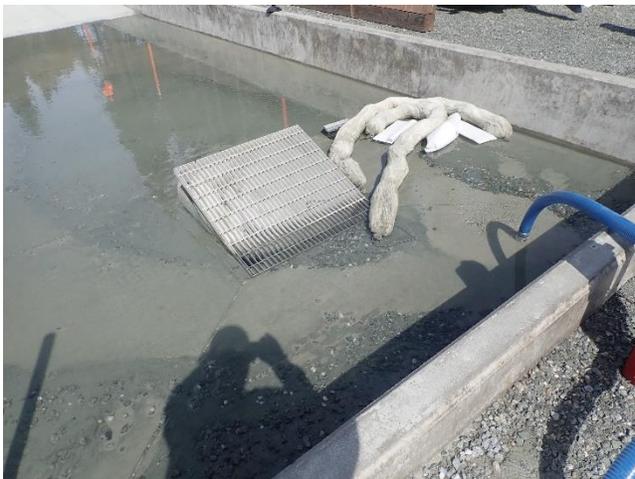
**Photo 21. The fuel depot refueling pad.**

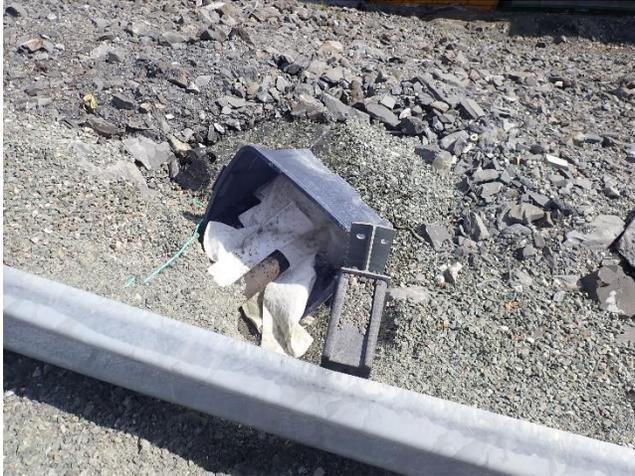
**Photo 22. The refueling pads outlet drain.**
